MINISTRY OF ENVIRONMENT

Solid Waste Sector

POTENTIAL LANDFILL SITES SURVEY

1-INTRODUCTION

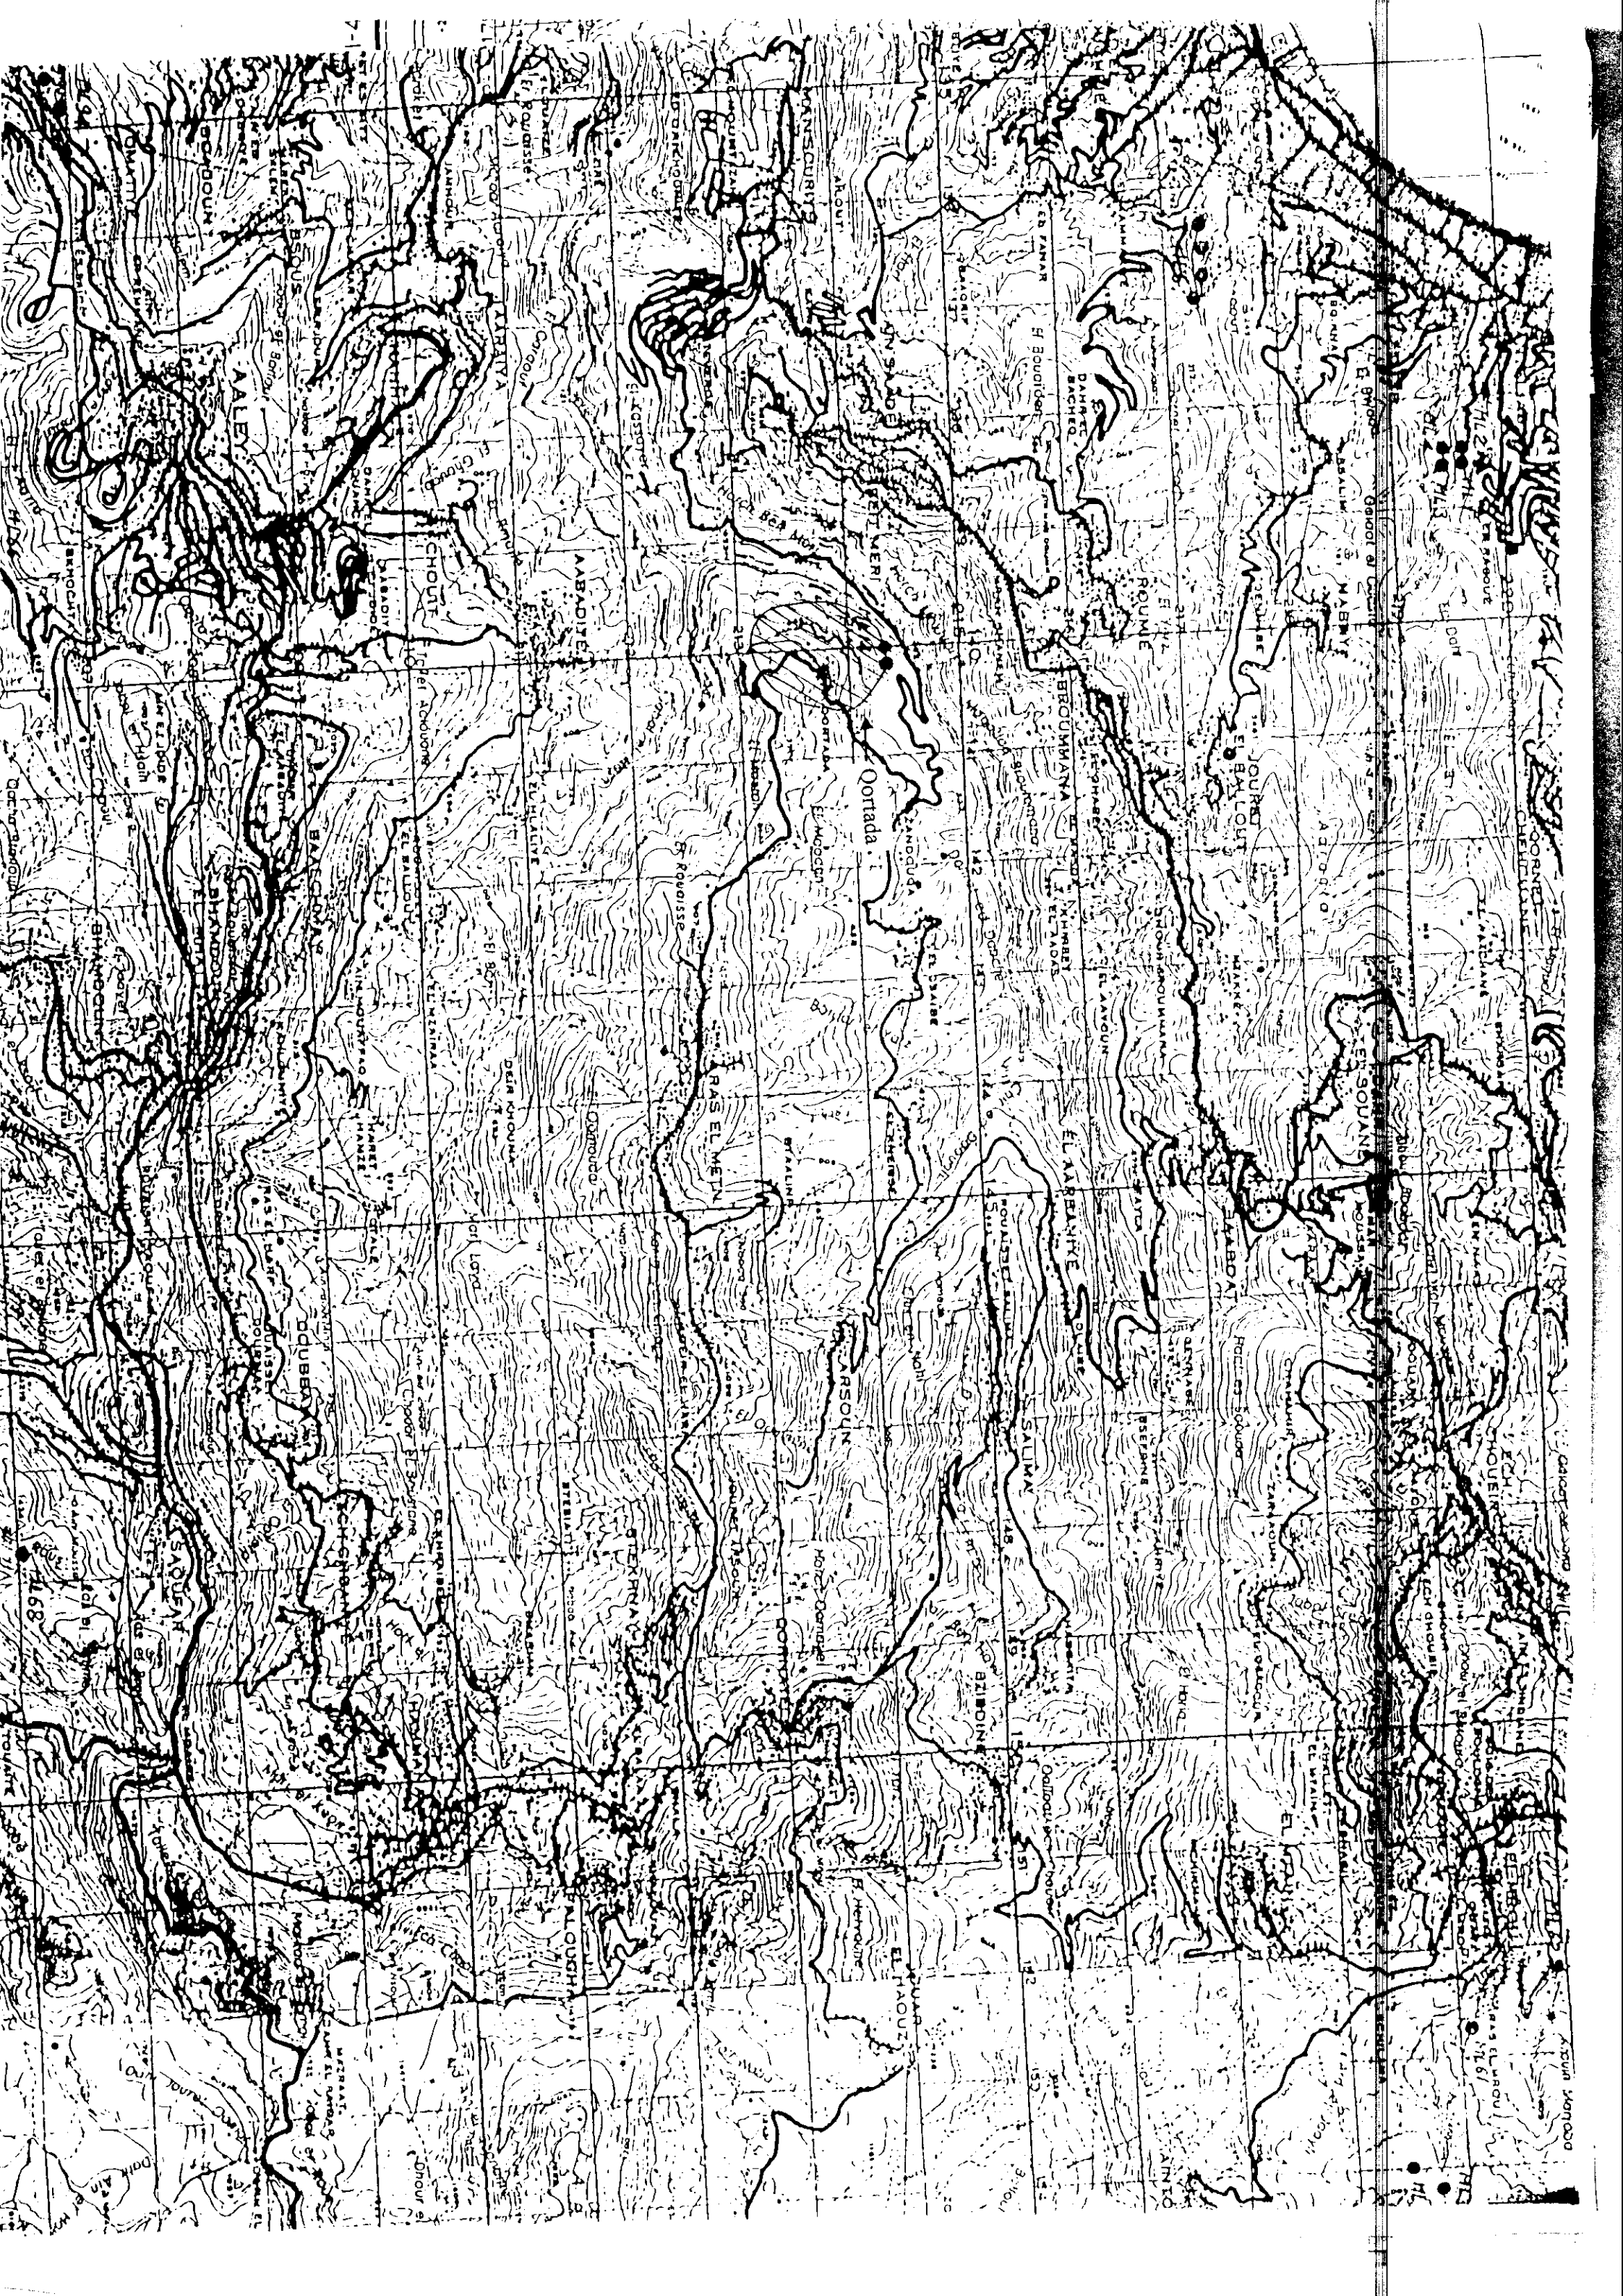
Qurtada

The Quortada quarry site cannot be retained as a potential candidate site for the construction of a landfill mainly due to its unfavorable geologic and hydrogeologic conditions.

The site is located immediately adjacent to the major tributary of Naher Beirut. The proximity of the site to a water body will immediately disqualify the site as a potential candidate for landfill due to the significant risk of water contamination.

Additionally, the site is located within the Jurassic aquifer which is considered to be the main aquifer of the region. Major groundwater withdrawal points are located downgradient and more specifically in the Daichounieh and Hazmieh area. These

withdrawal points are supplying water for the Greater Beirut area. Any groundwater contaminants that leach into the ground will likely contaminate these areas.

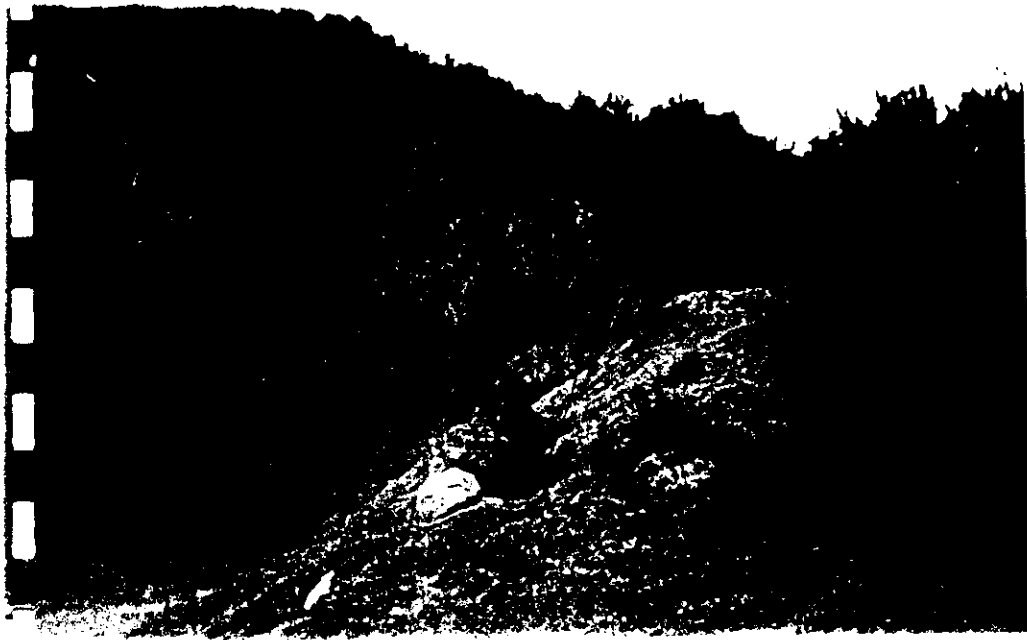
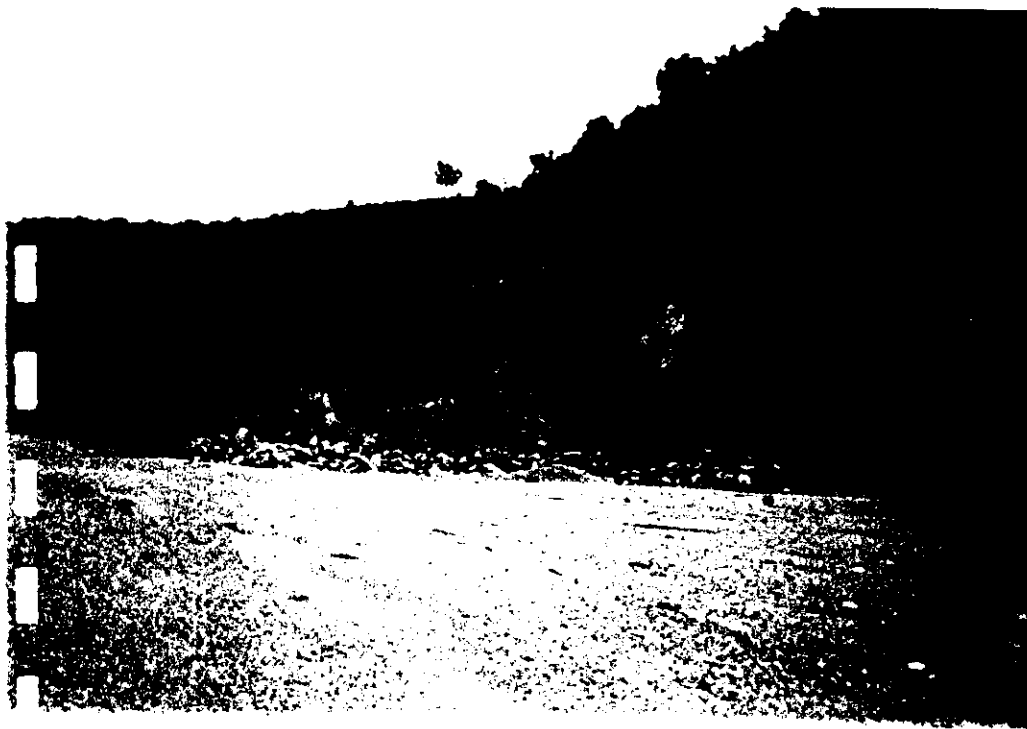
The Mounsef Quarry site was retained as a potential landfill site pending further evaluation. The site has a potential large storage capacity. The site appears to be located away from residential areas. The existing road infrastructure appears to be adequate. The local road that leads into the site does not appear to pass through residential areas. The groundwater beneath the site appears to be already contaminated by seawater intrusions. Thus, groundwater usage in the downgradient areas appears to be restricted due to seawater intrusions.

A comprehensive Environmental Impact Assessment study which includes a geological, hydrogeological, and geotechnical investigation should be conducted in order to provide a firm assessment on the suitability of Amchit site 1 and Mounsef site for the construction of a landfill.

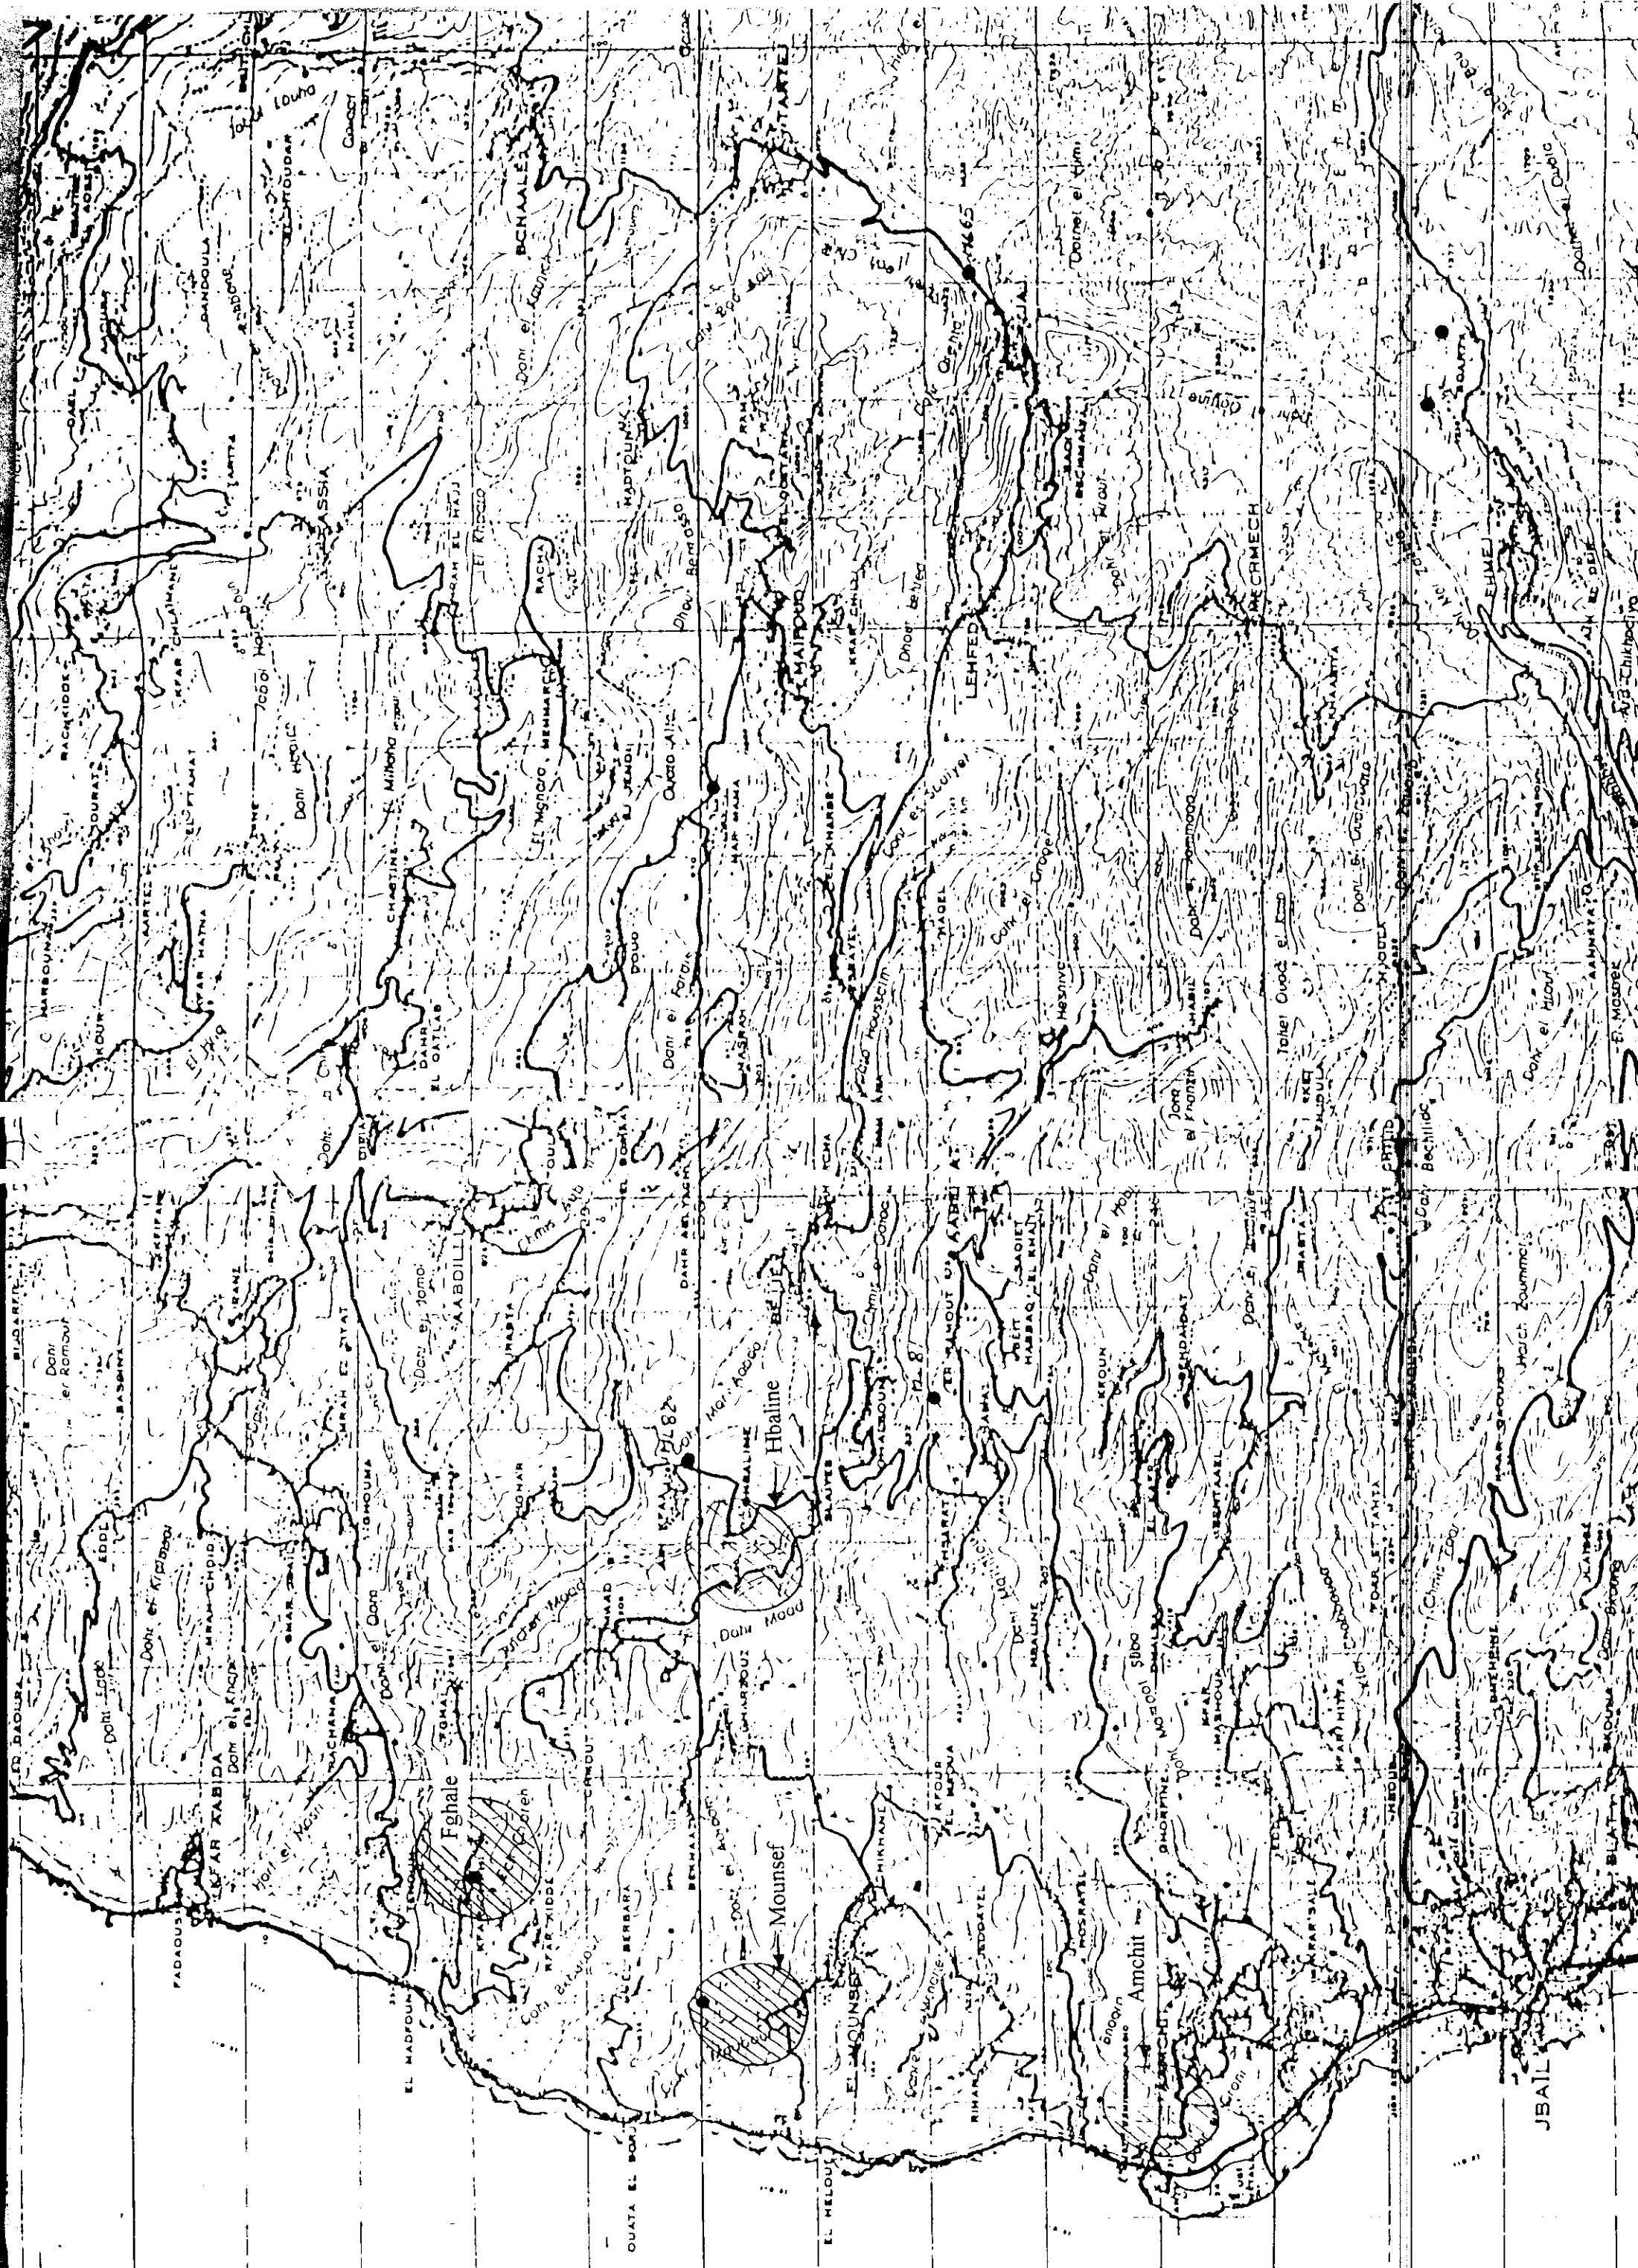
A brief discussion of the evaluation of each site is presented below . A regional geological map prepared by Dubertret (at a scale of 1/50,000), which shows the location of the 5 sites in Jbail area (i.e. 2 in Amchit , and one in each of Fghale, Hbaline, and Mounsef area) is presented in figure 4. Dubertret's regional geological map of the quortada area is presented in figure 5 .
