**ENVIRONMENTAL AND SOCIAL  
SAFEGUARD STUDIES FOR LAKE  
QARAOUN POLLUTION  
PREVENTION PROJECT**

COMPREHENSIVE PERFORMANCE  
AND ENVIRONMENTAL AUDIT  
OF AITANIT WASTEWATER  
TREATMENT PLANT

**AUDIT REPORT**

**August 7, 2015**

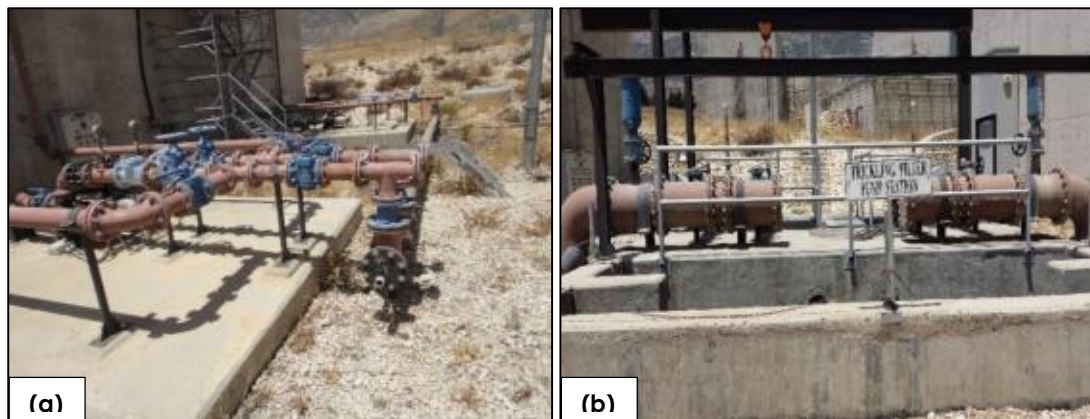
- Some pumps were out of service namely; the influent pumps, the RAS pumps, the trickling filter pump and the digester pumps. These submersible pumps were installed on concrete skid and exposed to sunlight and heavy rainfall without an adequate connection to the cooling media recycle causing operational damages and disturbances (Figure 3-1).

**Figure 3-1** Pump stations for digester tanks (a) and Trickling Filter Unit (b)

Problems/Deficiency	Location	Type	Rating	Recommended Action	Cost
The service pumps are out of service	Pumps	Technical	B	It is recommended to repair the plant water pumps.	800 USD/pump
Frequent damage to the functionality of primary clarifier and trickling filter pumps' upon exposure to heavy rainfall and sunlight	Primary Clarifier and Trickling Filter unit	Technical	B	The area of related pump skids and its control panels shall be shaded in order to avoid any unexpected damage upon exposing to sunlight and heavy rainfall.	12000 USD
The effluent is not clear; suspended solids, turbidity, grease and scum present in the treated water.	Effluent discharge point	Operational	C	It is recommended to conduct routine analysis for treated water prior to permission of use it in agriculture.	500 USD/test
Treated effluent is discharged through the chlorine basin without disinfection. The discharged water are used by the farmers to irrigate the cultivated land of the surrounded area. Small volumes of the treated effluent are used in the plant for miscellaneous purposes.	Effluent discharge point	Technical	D	It is recommended to restrict the reuse of the treated effluent in agriculture for category 1 and 2 considering crops selection, in case disinfection limits were not achieved it can be used for irrigation of category 3 crops without further treatment.	Cost of conveyance of treated water to irrigation areas to be bared by farmers

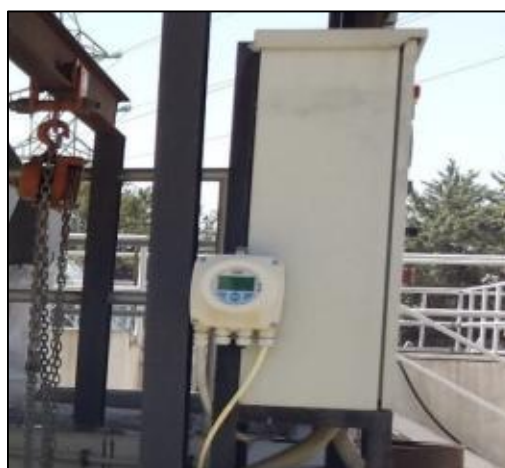
- Flow measurement device is not properly installed
- An in-line type magnetic flow meter is located next to the fine screening unit and installed at the influent pump discharge line (ABB Brand) to measure the plant's influent flows. This flow meter is very sensitive to air bubbles and cannot distinguish entrained air from the process fluid; therefore, air bubbles will cause the meter to read high values (Figure 3-3).

**Figure 3-3** Influent Flow Meter

Improper placement of flow measurement device.	Manual bar screen	Structural	B	Install a Parshal flume and level detecting device for flow measurement and high influent flows detection upstream of coarse screen channel.	10,500 USD
Grease pass through the plant to show up in the final effluent due to the absence of oil and grease removal tank.	Static screen	Structural/technical	D	Add an oil and grease trap upstream of the fine screen and use more frequently the primary clarifier Skimmer to remove free	8,000 USD

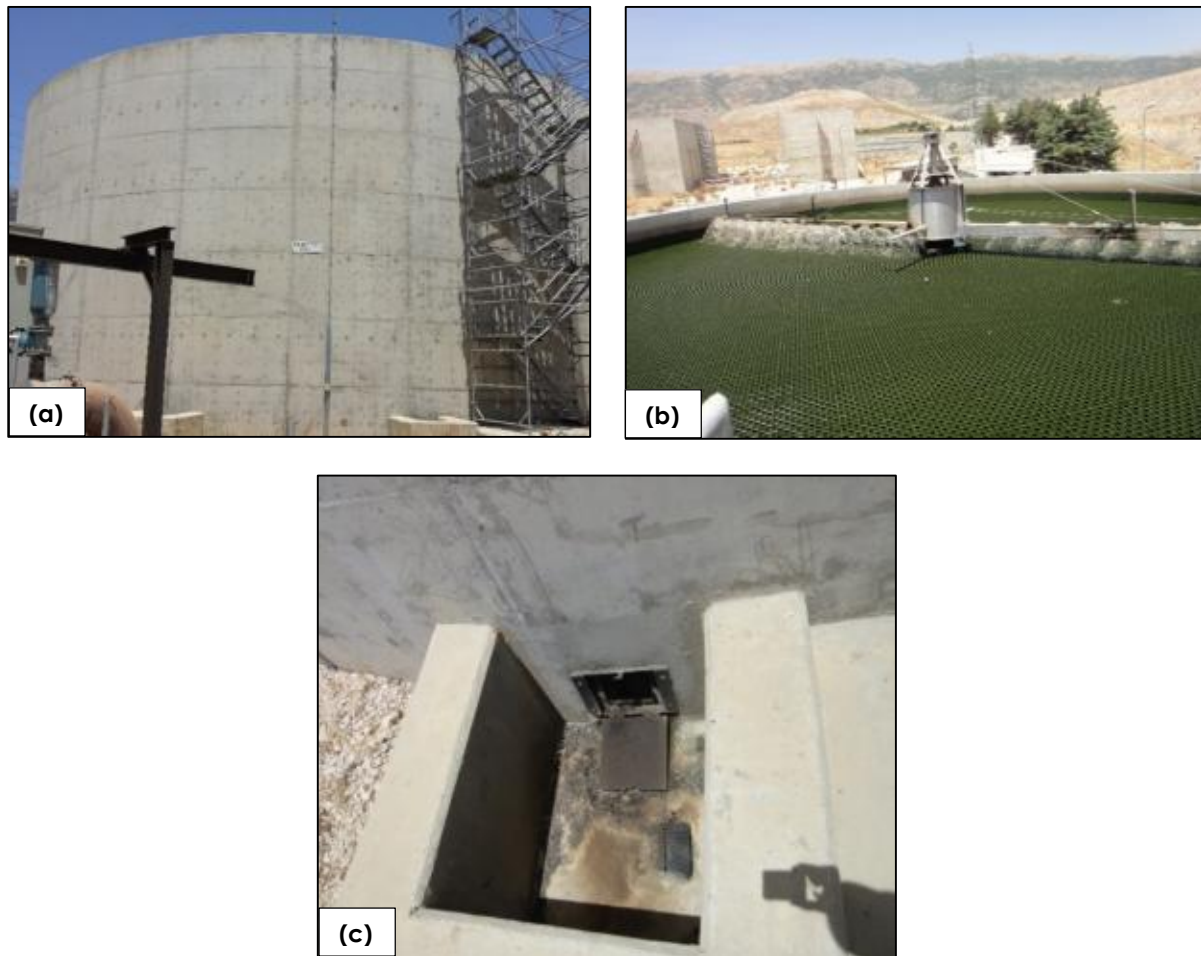
- This filter is equipped with an underdrain system that collects the filtrate and solids that are then conveyed to the settling tank. Part of the filtrate is recirculated through the trickling filter by the trickling filter recirculation pumps. Adequate doors for passive ventilation and fans for forced air are provided. Vent doors are shut when the fan is running (Figure 3-6).
- A thin layer of algae is observed on top of the filter.

**Figure 3-6** Trickling Filter Unit showing the main TF building (a) and the rotation of distribution arms (b) and Ventilation door (c)

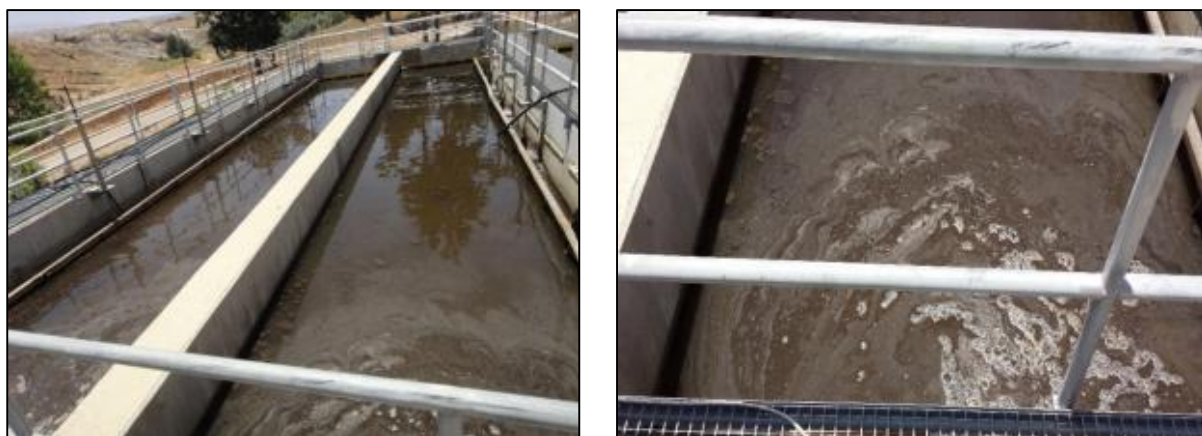
- A secondary settling tank composed of three clarifier tanks (two are in use), each equipped with six manually activated telescopic valves installed in a GRP Channel to draw off the sludge from the bottom hopper of the tank into the GRP are observed (Figure 3-7).

- Excessive gas bubbles, floating bulks and rising sludge appeared on the surface of the wastewater. This indicates improper settlement of sludge and forming clouds caused by filamentous bacteria and denitrification process inside the clarifier. Tiny floc particles that were moving to the final clarifier weirs increased the turbidity of the effluent.

**Figure 3-7** Secondary or Final Clarifier showing sudsy, billowing and bulking sludge

Problems/Deficiency	Location	Type	Rating	Recommended Action	Cost
overflowing the weirs; the effluent from the settling tank contains a high concentration of suspended solids.				bubbles of nitrogen act as a sludge carrier. Remove sludge more frequently from Secondary clarifiers to avoid excessive de-nitrification.	
Treated effluent is discharged without disinfection. As a result, the level of Coliform exceeds the maximum allowance to be discharged to surface water.	Chlorine contact basin	Technical/logistics	D	<p>Most of water is being reused for irrigation purposes due to the lack of water in the area, However, it is recommended to apply chlorination to the treated water before discharge it to the river or use it in irrigation. The Actual Operator (Union of Municipalities of the Lake) is required to allocate enough budget for the operator to operate the choline addition system.</p> <p>MoWE/BWE will implement the Environmental Monitoring Plan included in the Amended Environmental Impact Statement Small Village Wastewater Treatment Systems "EIQC – TO818" dated November 2005. Especially more rigorous monitoring is required for Coliform. The operator must ensure that treated effluent meets applicable requirements prior to land application for agricultural uses.</p>	24,000 USD

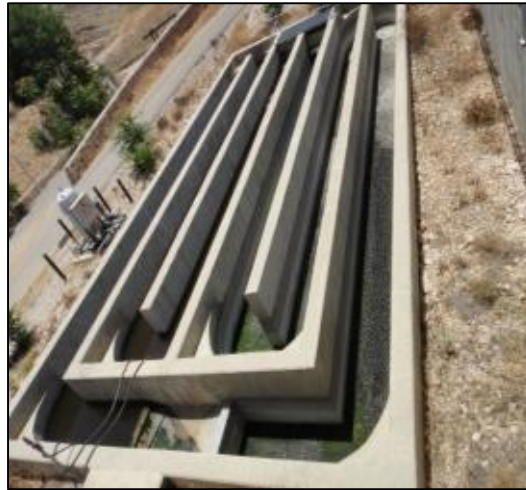
- The treated effluent is being discharged in the river without disinfection, even though chlorine dosing pumps are available.
- No disinfecting agent is found in the Chlorine contact tank (Figure 3-8).
- The chlorine feeding room is not equipped with eyewashes.
- The chemical solution tank for the preparation of the chlorine solution is missing. Instead, a 20-L drum is being used for chemical solution preparation.
- No chlorine test kit was available at the time of the visit.
- The chlorine agent was expired at the time of the visit.

**Figure 3-8 Chlorine Contact Tank**

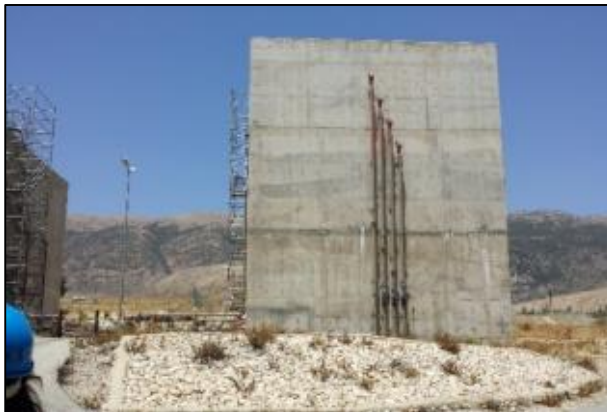
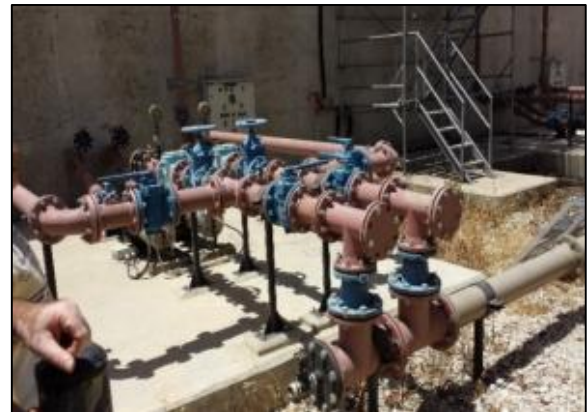
**Figure 3-9 Digester tank and its pump station**

Problems/Deficiency	Location	Type	Rating	Recommended Action	Cost
The anaerobic digesters contain dead areas without any mixing.	Anaerobic digester	Structural/operational	C	Add an adequate mixing technique such as agitator to insure proper mixing in the anaerobic digester and enhance sludge digesting.	15,000 USD
The anaerobic digesters are not operating properly.	Anaerobic digester	Operational	C	Improving the load distribution between multiple tanks is required and can be achieved by using two digesters for the primary scum and two for the final scum with the focus on increasing of sludge concentration.	NA
Sludge is stored all the year in liquid form to be dried in summer. No draining is allowed from sludge drying ponds.	Sludge drying ponds	Operational	C	<ul style="list-style-type: none"> <li>The operator should develop a sludge management plan in accordance with the Ordinance on the use and disposal of sewage sludge to improve the sludge disposal practices and provide landfills for disposing the sludge with regular analysis. The only existing sanitary landfill is Zahle. There is a planned landfill in Jeb Jannine to be used when fully constructed.</li> <li>Insure proper operation of the drying ponds sluice gate to allow supernatant evacuation and reduce the time required for drying.</li> </ul>	3,000 USD

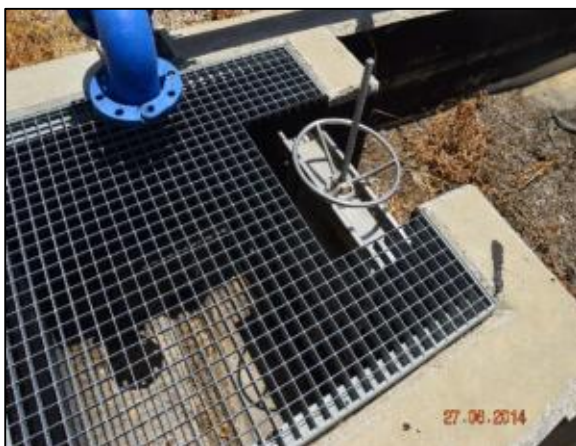
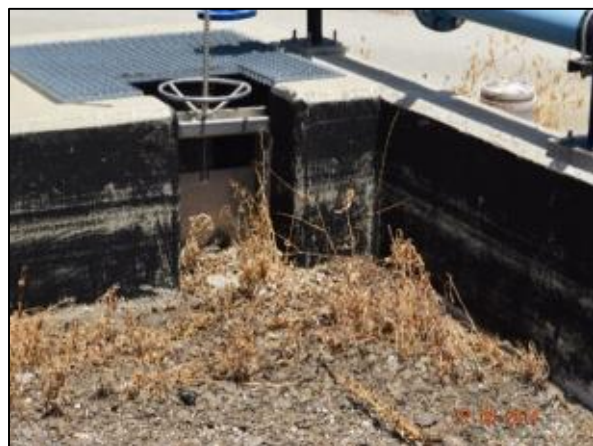
- The supernatant evacuation through the sluice gates is not effective because these open from bottom to top instead of top to bottom to allow supernatant, which accumulates on the top to be released (sludge deposits on the bottom of the ponds and the supernatant remains on the top)(Figure 3-10).
- Ten drying lagoons are available within the Aitanit WWTP. After the digestion process, solid sludge is conveyed to the drying lagoons for dewatering purposes (Figure 3-11). The sludge drying ponds contain sludge during winter and summer which is unsafe especially during rainfall periods.
- Due to the lack of adequate sludge disposal practices the following was detected in the drying lagoons:
  - appearance of poor sludge distribution;
  - noxious odors (next to the ponds);

**Figure 3-10 Supernatant evacuation system of the sludge: sluice gates**

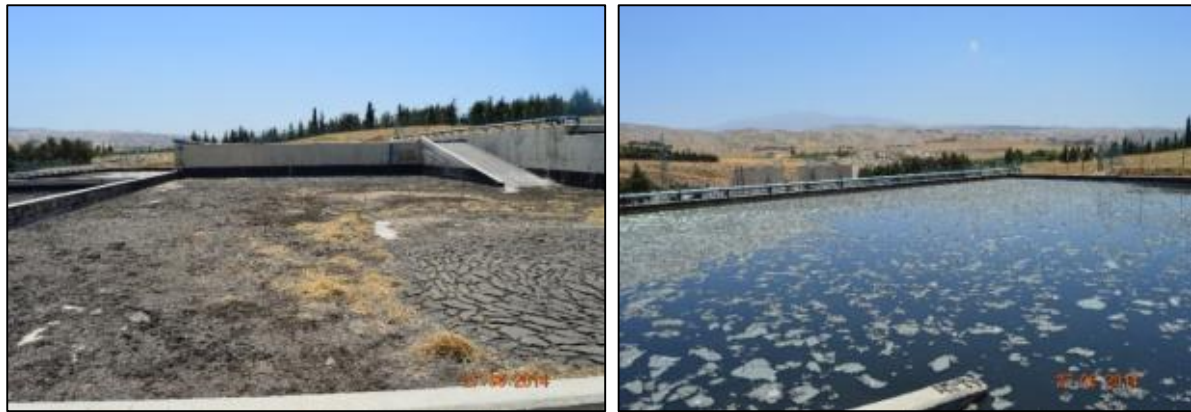
Figure 3-11 Sludge drying lagoons showing sludge cakes and vegetation

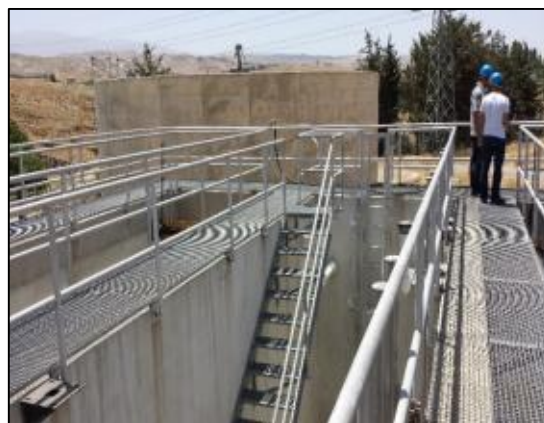
Figure 3-12 Safe Catwalk and Ladders

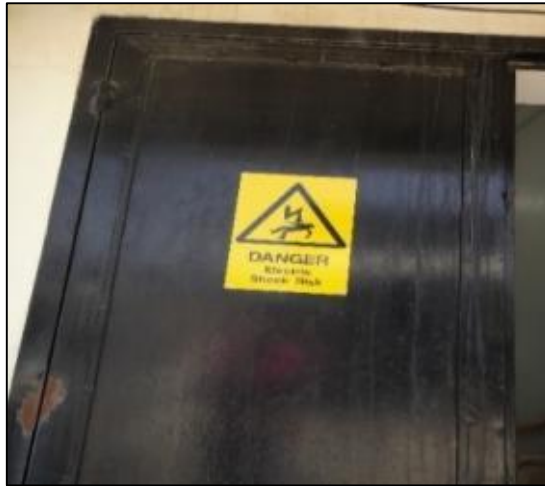
**Figure 3-14      Warning Sign**

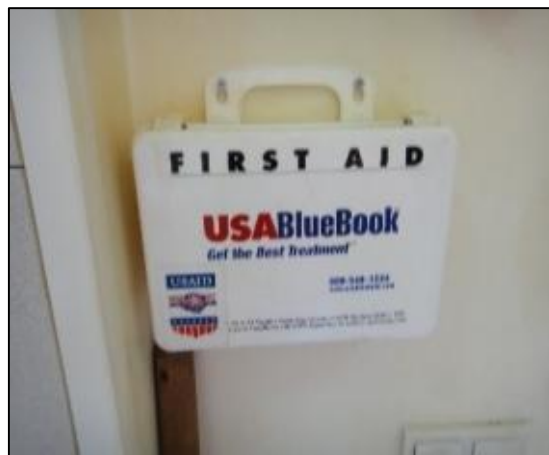
- First aid kit is available in the plant but most of the medicines are found to be expired (Figure 3-15).
- Fire extinguishers are available at the plant but the expiry dates are passed and the extinguishers have not been renewed (Figure 3-16).

**Figure 3-15      First Aid Kit**

First aid kit is available but most of the medicines are expired.	-	Operational	C	Insure that the first aid kit is always available and medicines are not expired.	150 USD
Power failure influence on treatment efficiency and sludge removal.	-	Operational	B	Aitanit is provided with electricity from Qaraoun Dam, it suffers from power outage only in drought season. The union of municipality is requested to supply enough diesels for the main generator of the plant to cover the power shortage.	2000 USD/ month

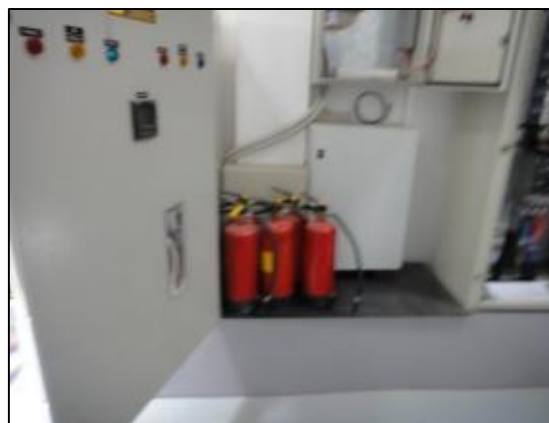
**Figure 3-16      Fire Extinguishers**

Problems/Deficiency	Location	Type	Rating	Recommended Action	Cost
No adequate measures for odor control are considered or applied in the plant design and construction.	-	Operational	D	<ul style="list-style-type: none"> <li>Add a mechanism of Hydrogen Peroxide injection for headwork's odor control. Hydrogen Peroxide typically controls odors and corrosion at the WWTP by direct oxidation of hydrogen sulphide (H<sub>2</sub>S) within the wastewater.</li> <li>Implement a green belt to reduce the odor emissions and their spread.</li> <li>Insure routine relay of the sludge and the screenings out of the plant.</li> </ul>	800 USD for setup and 1,750 USD/year
The plant is equipped with a fire alarm system but it is not operational due to its power battery failure.	-	Operational	C	Fix the fire alarm system and put it in service.	250 USD
Fire extinguishers are available in the plant but they are expired.	-	Operational	C	Insure that the fire extinguishers are always filled and not expired.	500 USD
