Relèvement de la production piscicole  
dans la plaine nord-est de la Bekaa

FLOOD IN THE N.E. BEKAA VALLEY

(15th June, 1987)

FAO Representation

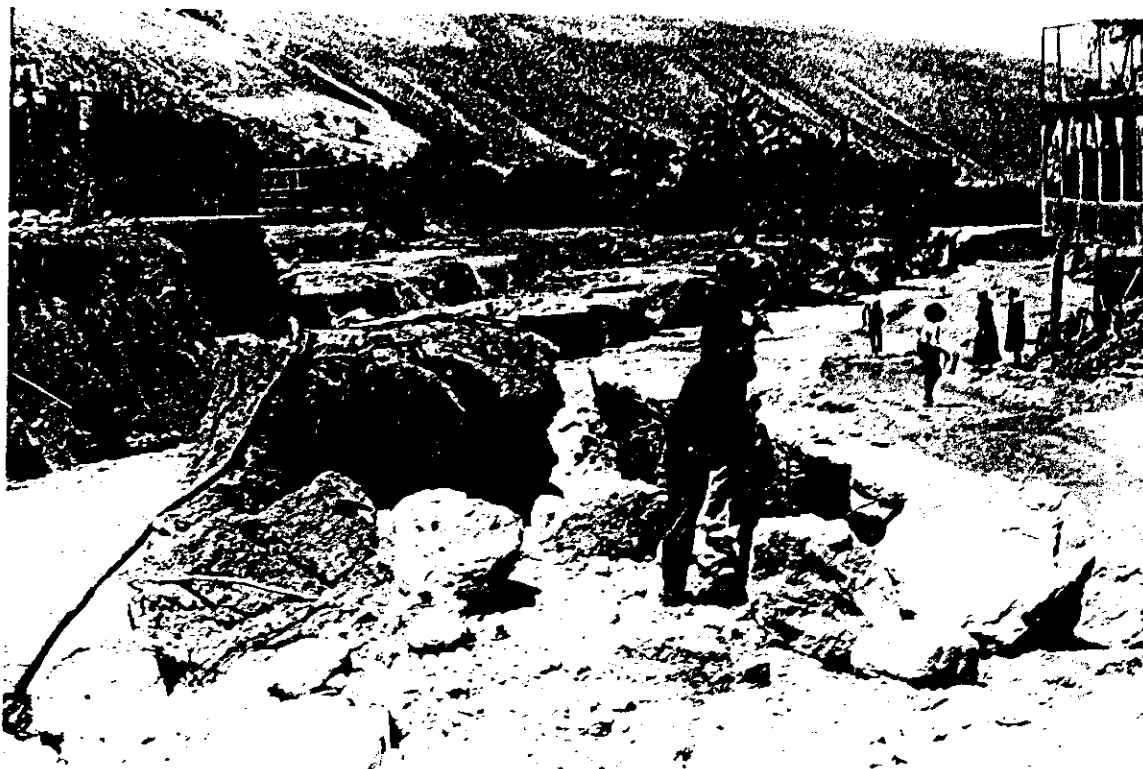
- Infrastructure :-water distribution system
- electricity
- houses
- Erosion of soils (Picture 3)

Picture 3 : Erosion of soil.

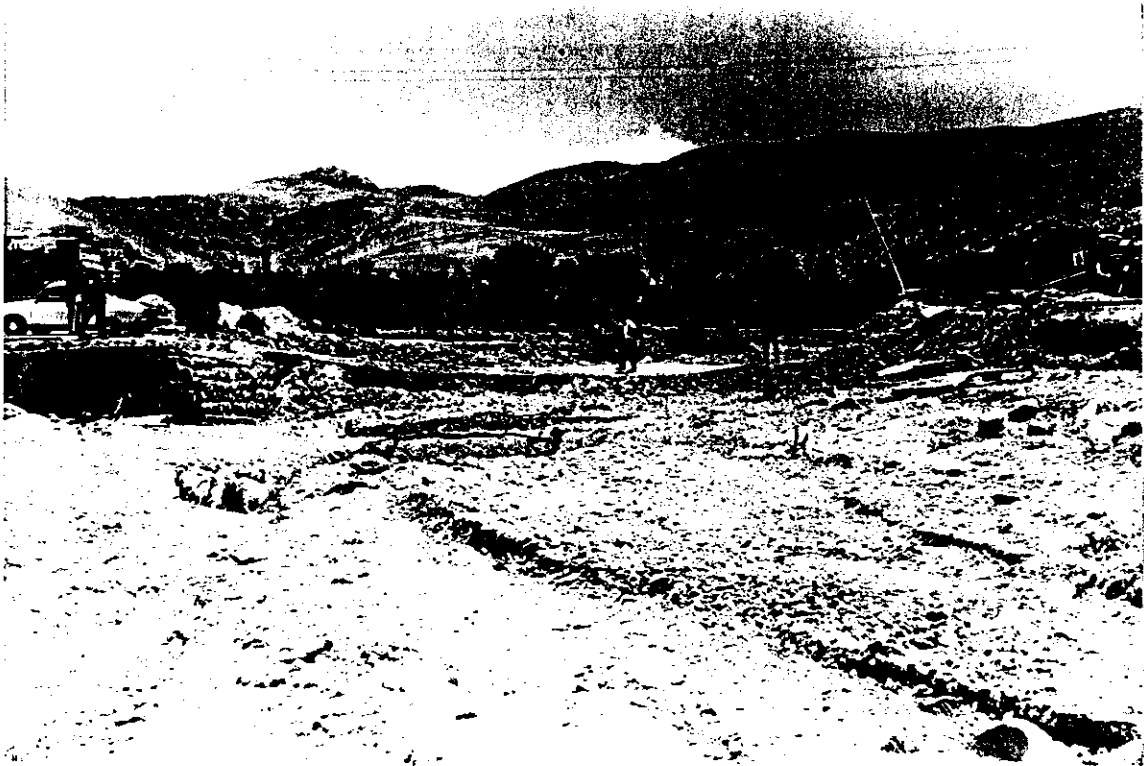
The Assi Valley consists of a long strip of irrigated land along the Assi River (40 km long) with fruit trees as major crops and vegetable production among and in-between the fruit trees. Many bridges join the two banks of the river (Picture 5).

Picture 5 : Bridge destroyed by the flood.

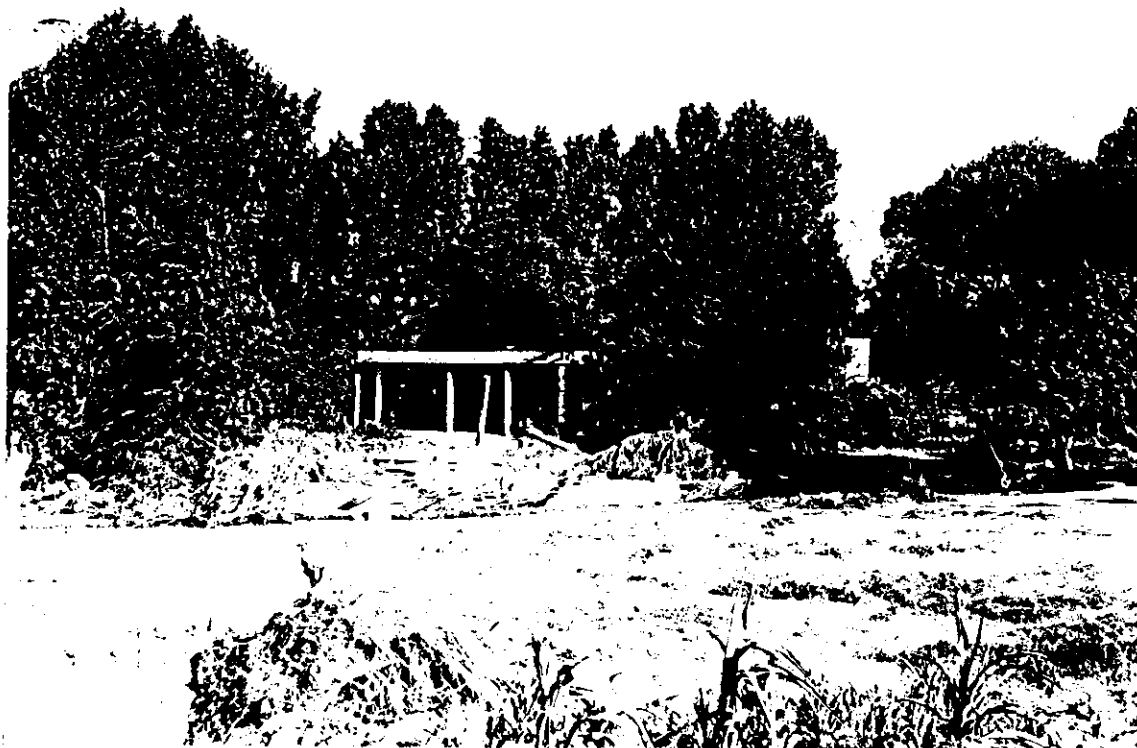
Water being very muddy and stony swept the fish not only in the river but also in the fisheries next to the river, causing the complete loss of fish industry in this valley (Picture 6).

Picture 6 : Fish ponds submerged and destroyed in front of a house.

- rapid and temporary reconstruction of irrigation systems, and immediate provision of water pumps,
- restocking the Assi river and fisheries with trout fish (about 150,000 alvins).
